RE: Summary of Findings: USA v. Jamie Clemons, RDB-19-0438

## **REPORT OF FINDINGS**

**APPENDIX**

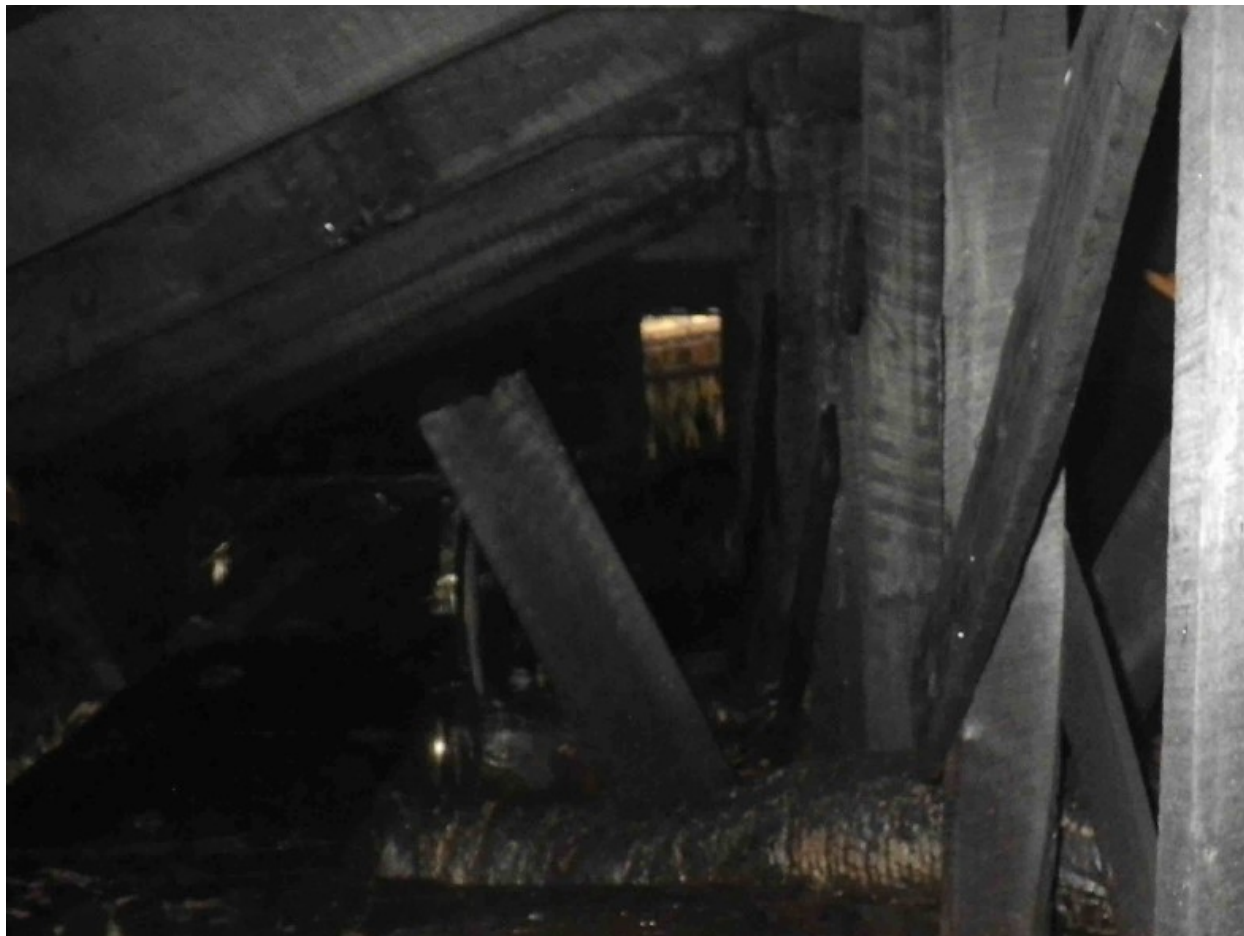
**Picture #5**

The investigation never considered electrical fire in the attic. The report makes no mention of the electrical wires in the attic area. Pictures show unsecured wires and improperly secured wires running through the attic space. (See Appendix- Pictures #5 and #8) The report does mention “the exposed ceiling joists displayed charring and mass loss from the top sides and down, saddle burns, indicating a top down fire progression within the attic space.” This would be consistent with an electric fire in the attic starting slowly into a steady state fire.

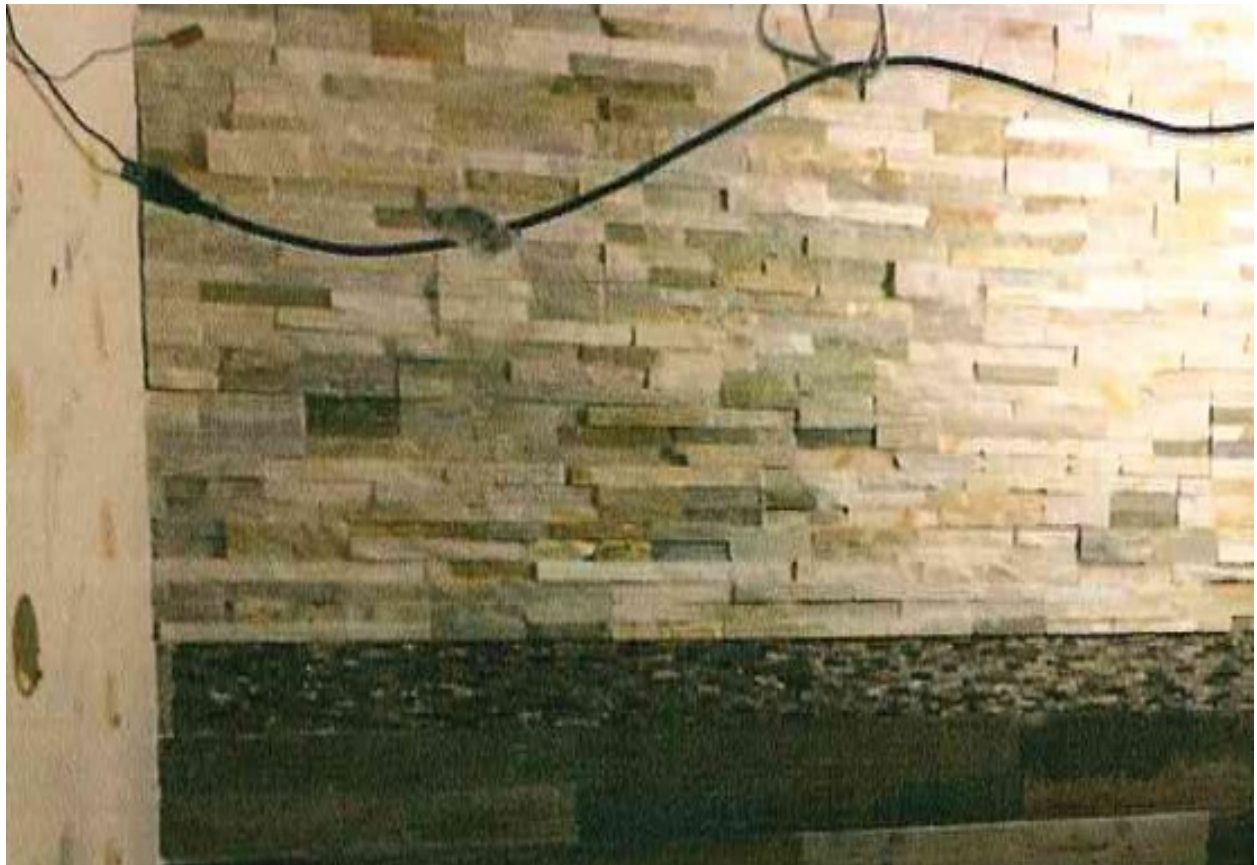
**Picture #9**

An interview conducted with Keith Plews (DOB 12/11/76) on 11/2/2020 revealed that Mr. Plews participated in an unpermitted complete remodel of the men’s bathroom of Coconut Charlie’s in February of 2017. (See Appendix- Pictures #9 thru #14) He left for Florida soon after completion of the men’s room and the other workers finished the women’s bathroom. He stated that “Jimmy” did the floor and wall framing, “Florida Rob” did the electrical and plumbing, and that he completed the tile work. A check with the Anne Arundel County Building Department

Bathroom remodel

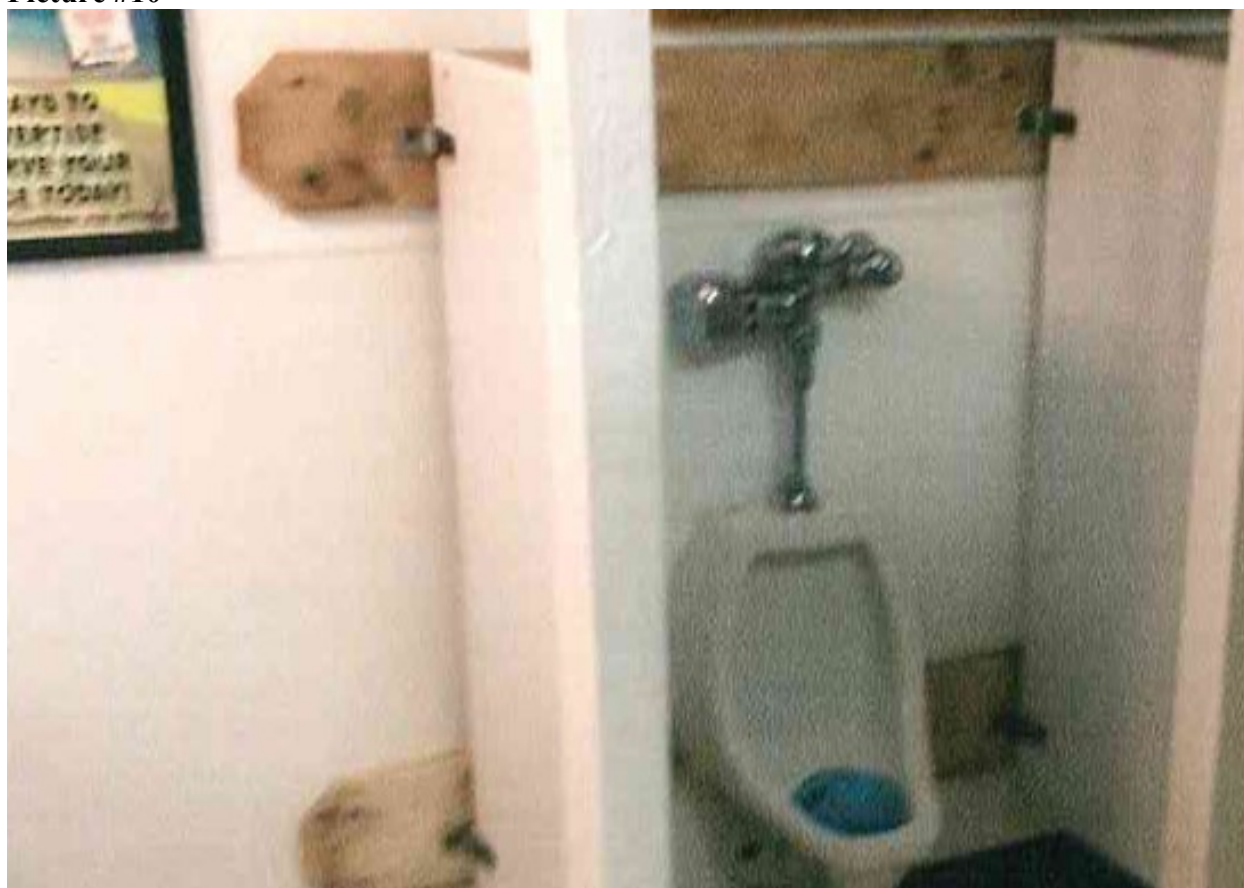
**Picture #10**

Bathroom before remodel

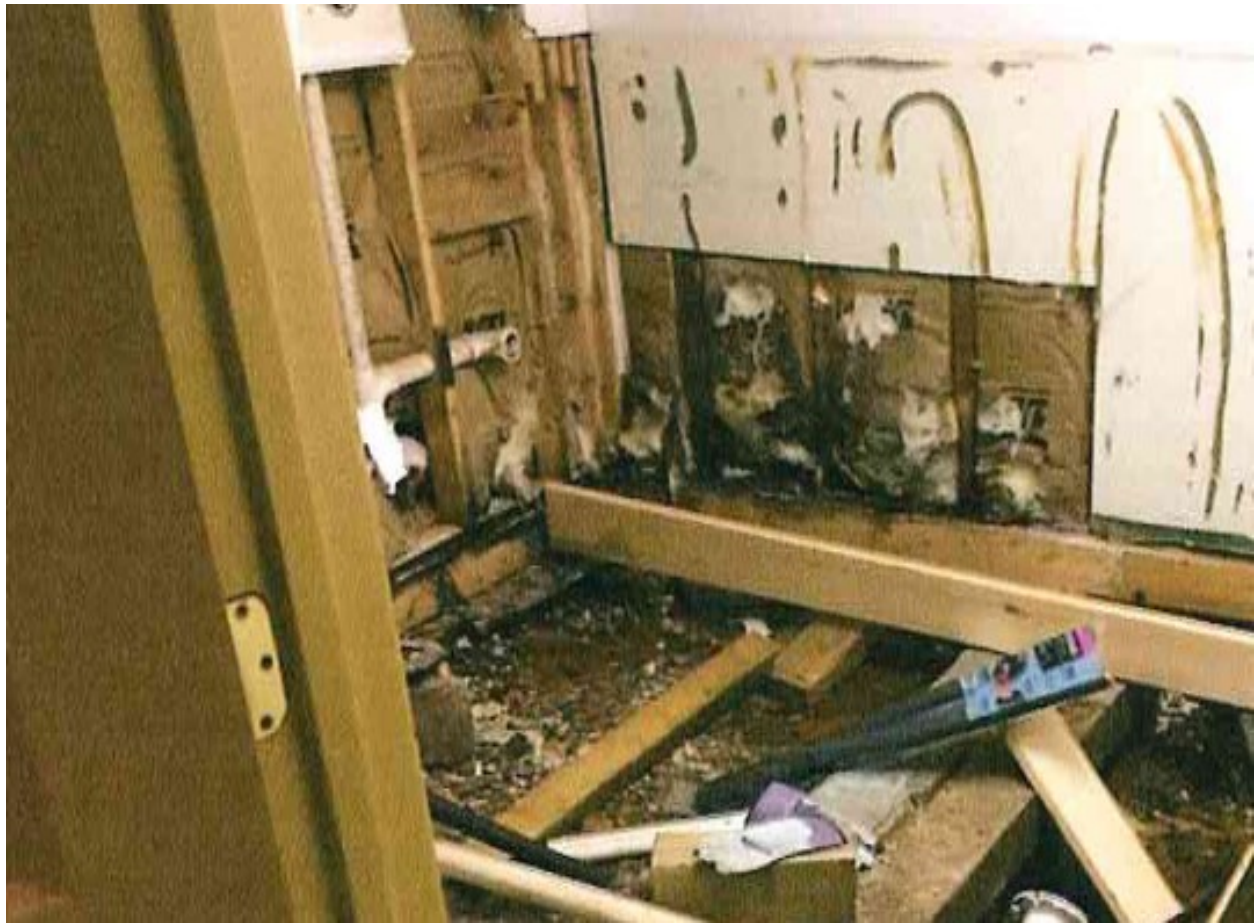
**Picture #11**

During Bathroom remodel

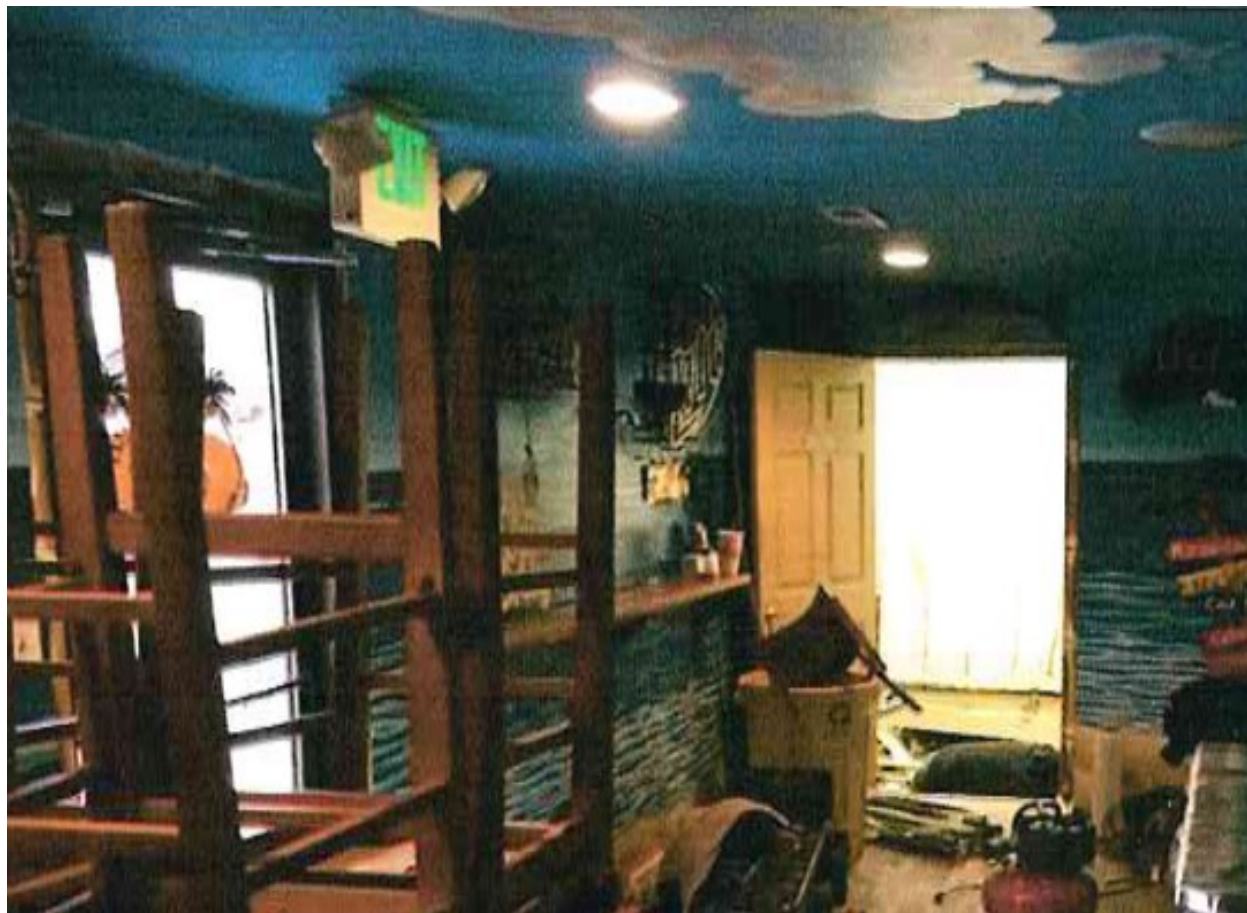
**Picture #12**

Outside Bathroom remodel

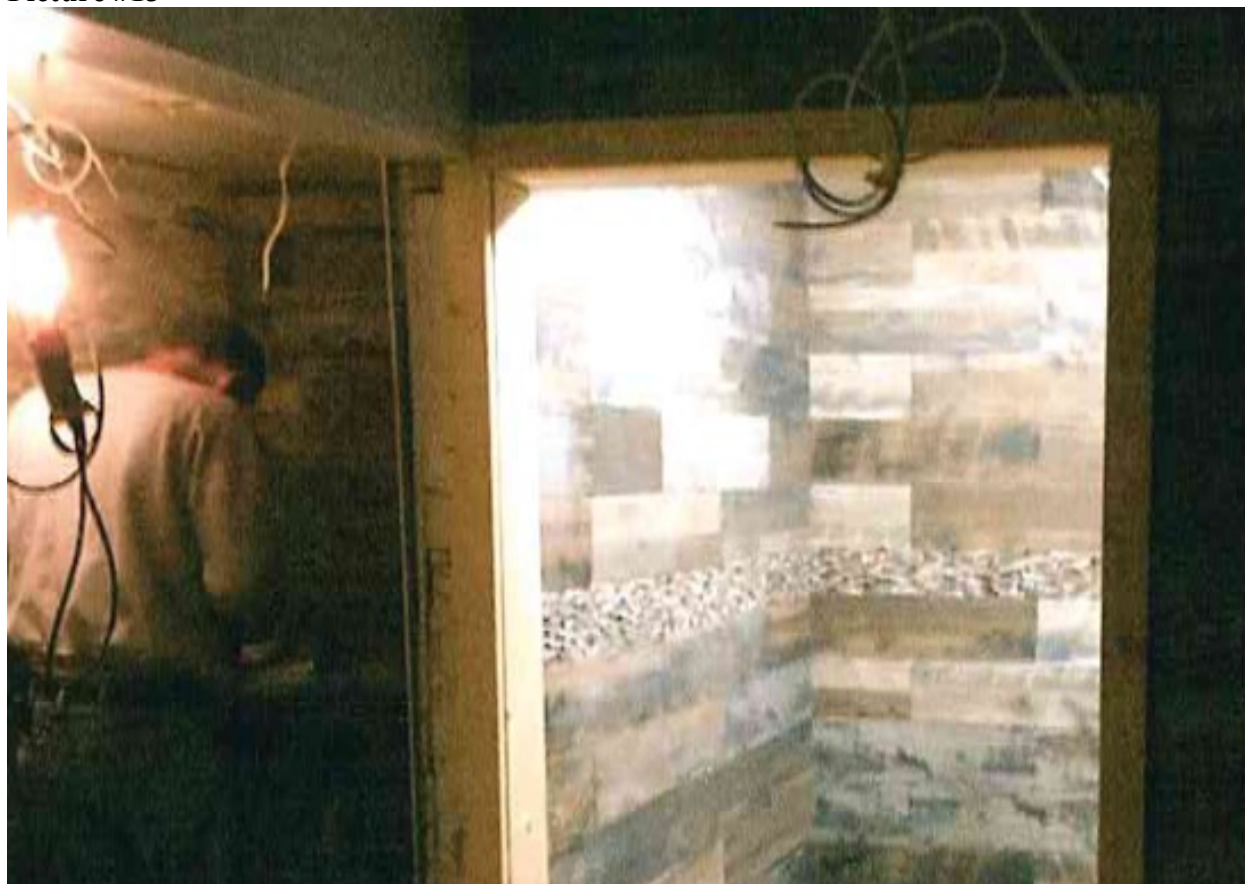
**Picture #13**

revealed that no permits were applied for or obtained, and the work was never inspected. Mr. Plews stated that the gentleman that performed the electrical work installed an exhaust fan and light fixtures in the ceiling. The wiring side of these fixtures were in the attic. The bulk of the fire damage in the attic is in the area over the bathrooms (See Appendix- Pictures #1 and #2). None of the workers were licensed contractors and none were Master electricians, plumbers, or mechanical.

Bathroom remodel roughed in wiring

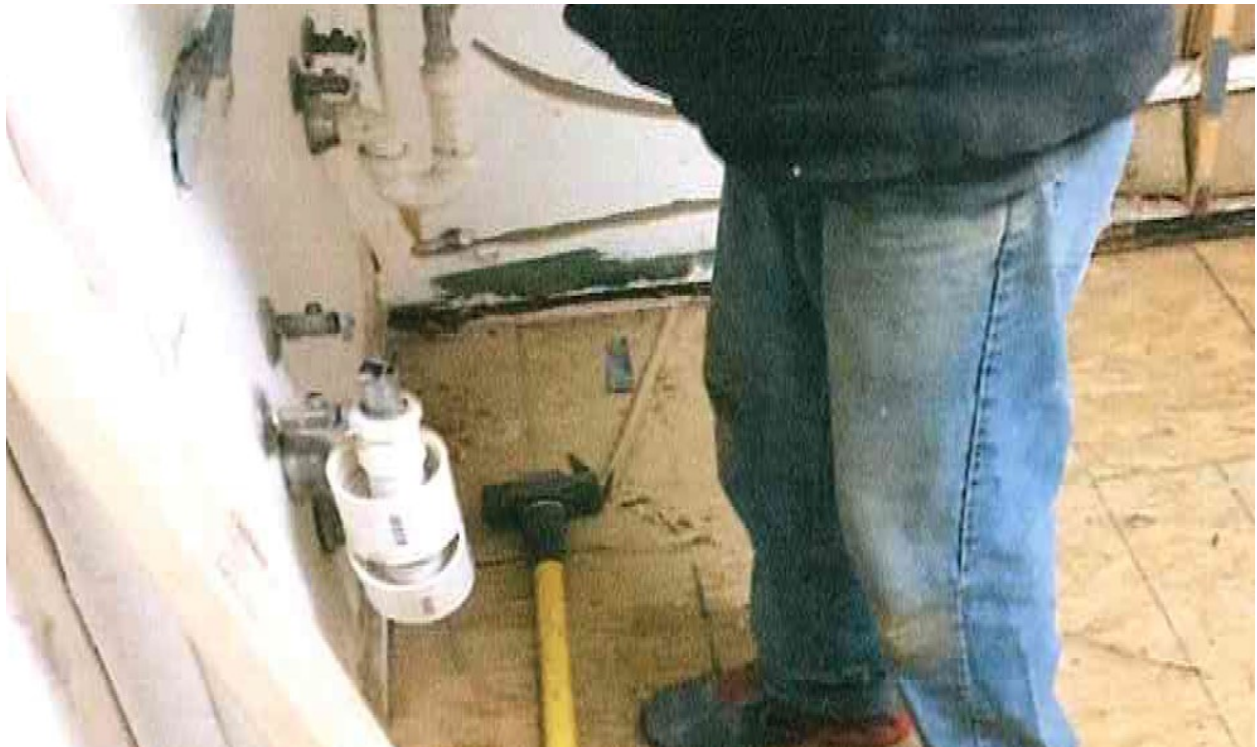
**Picture #14**

Bathroom remodel

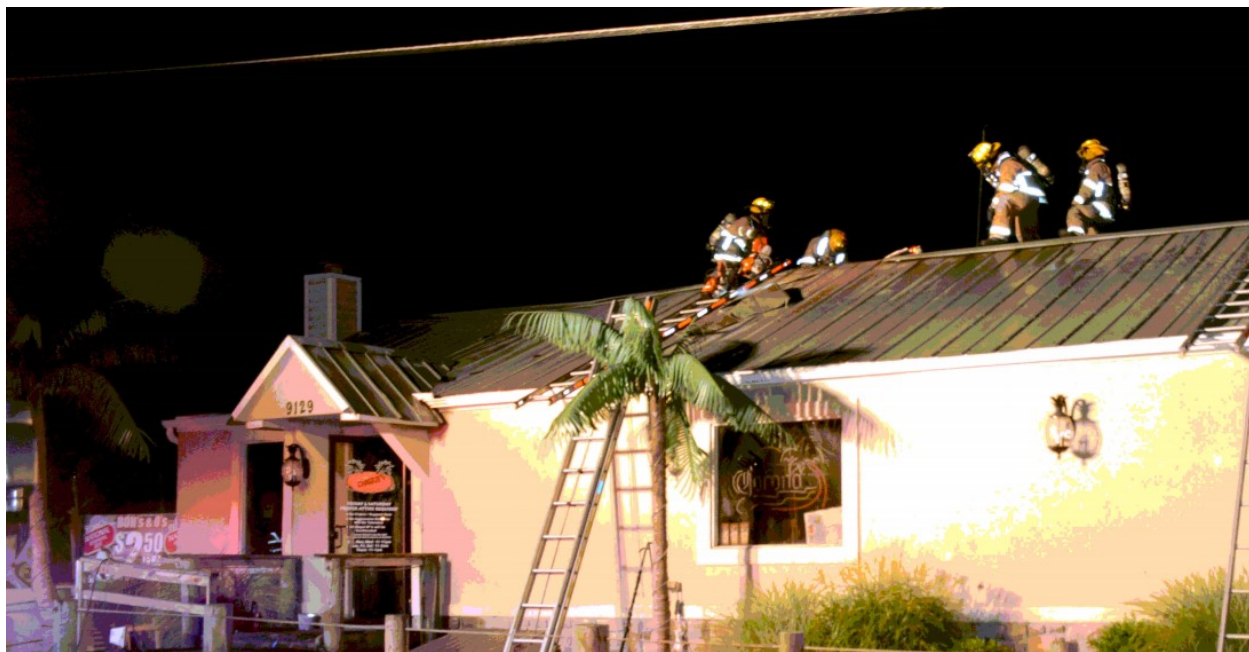
**Picture #15**

Fire crews working on the roof of Coconut Charlie's

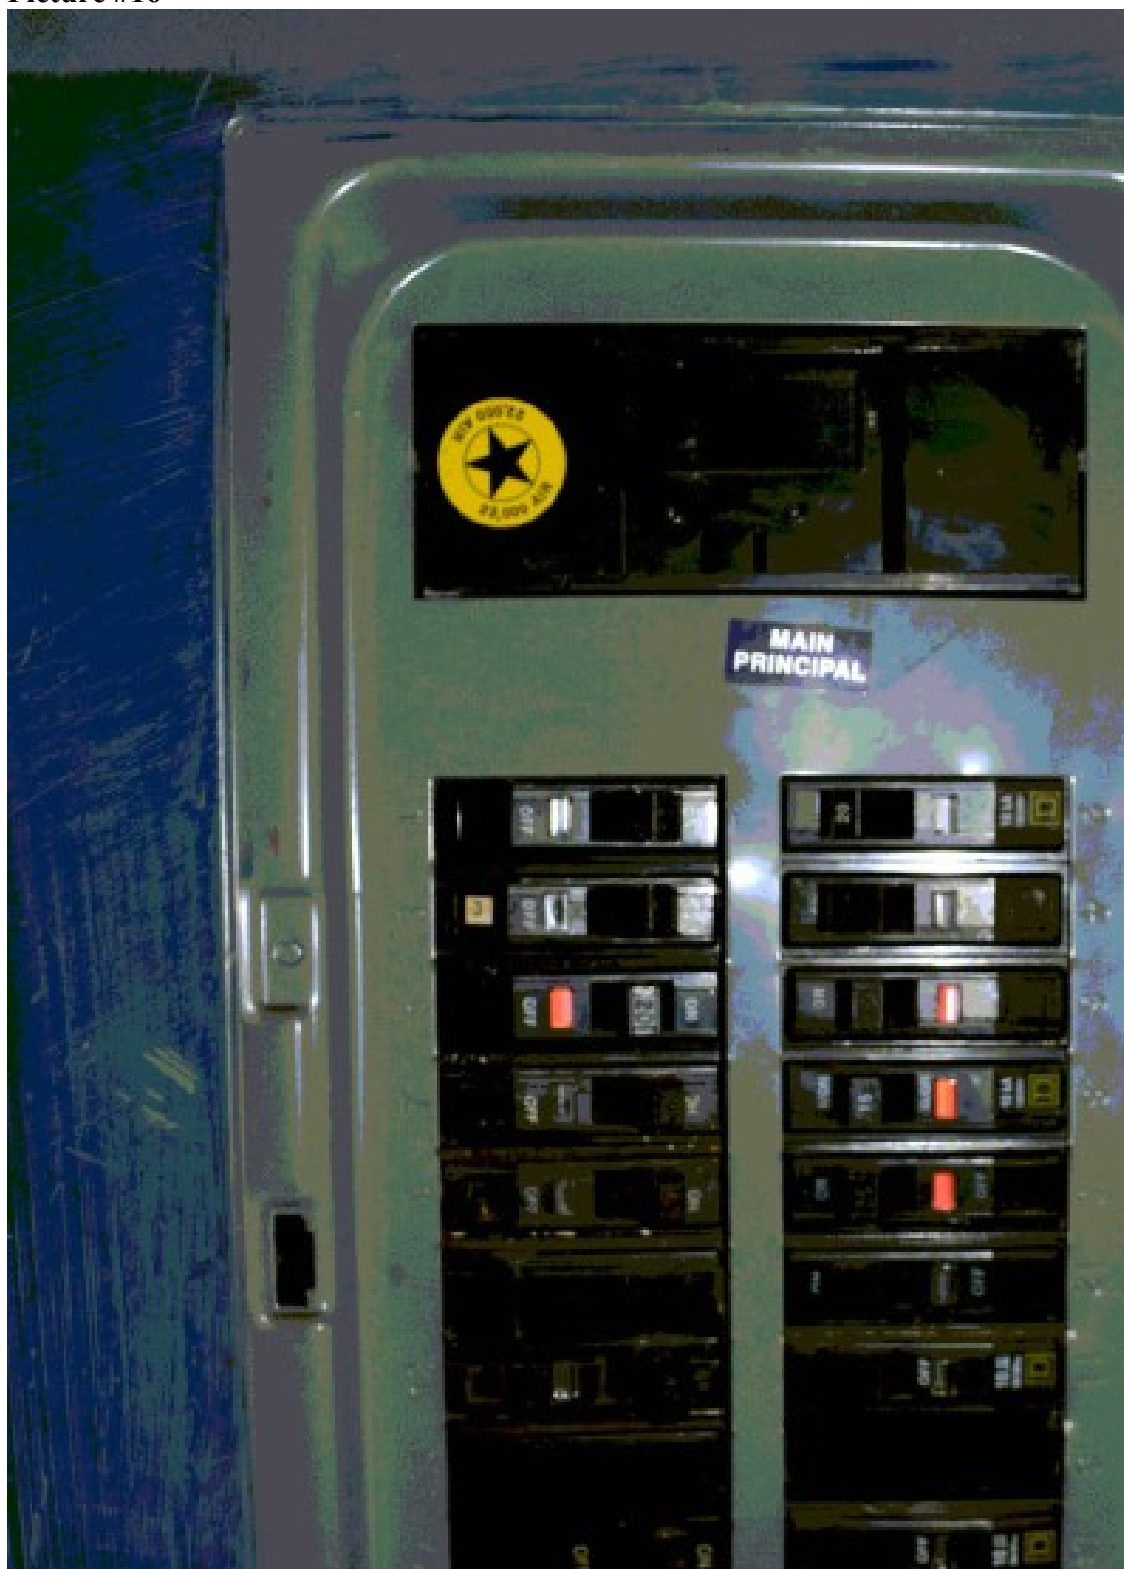
**Picture #16**

Examination of an electrical panel showed four (4) circuit breaker tripped: Breakers 5,6,8, 10. (See Appendix- Picture #16). Breaker 10 is labeled “Recess Lts” which most likely means recessed lights.

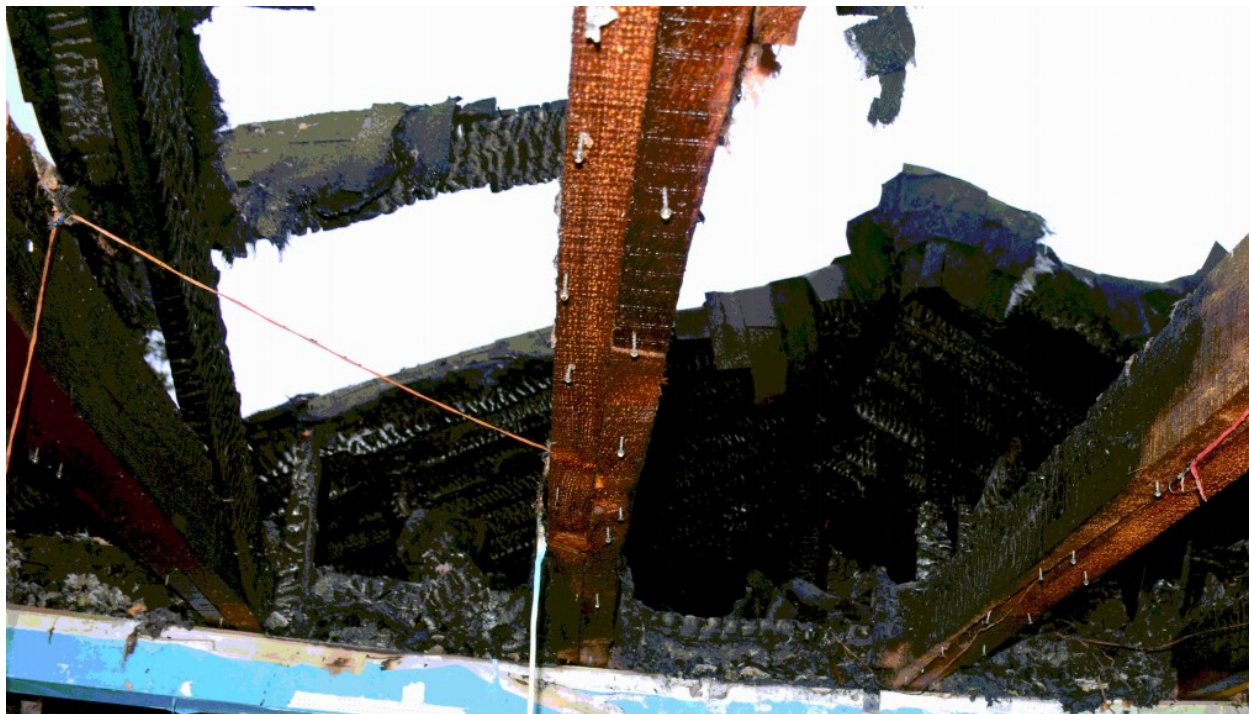
**Picture #18**

It appears that the fire originated in the attic area above the bathroom area, as evidenced by the heavy charring of wooden structural members in that area. (See Annex- picture #18). Ventilation efforts by fire suppression units which cut a hole in the roof to release hot gases and smoke for the fire engine crews to safely enter the structure and suppress the fire. (See Annex- picture #15) The other effect of the ventilation is to draw the fire in the attic towards the hole cut in the roof, which caused intense fire damage in that area.

In the area of origin were several unsupported wires and the electrical fixtures illegally mounted in the ceiling of the bathrooms, including recessed lights and exhaust fans.
